Model: STR-D565, STR-D665

No. 494

Subject: Noise in Rear Channel

Date: October 10, 1996

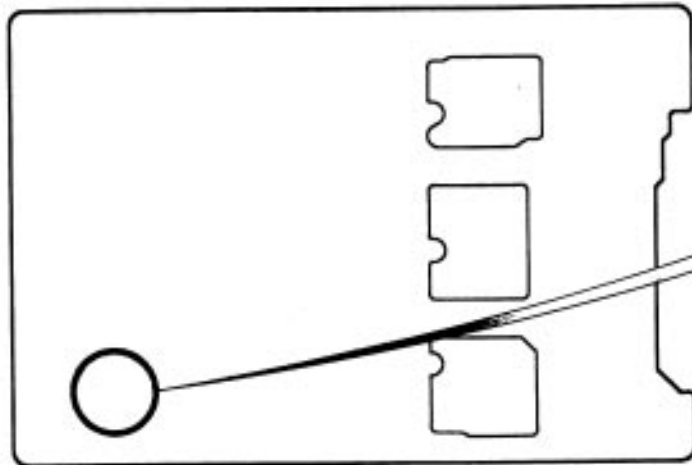
MAIN BOARD
— CONDUCTOR SIDE —

(154) The customer may complain of noise or distorted sound from the rear channel when the volume level is increased.

Solution: Add the following resistor as outlined below

REF	DESCRIPTION	PART NUMBER
N/A	100K OHM CARBON RESISTOR	1-249-971-11
